# **PRESERVING A COMMUNITY**

## **Historic Rehabilitation Standards and Guidelines**

## **THE VILLAGE OF THOMPSONVILLE**

**Enfield, Connecticut**

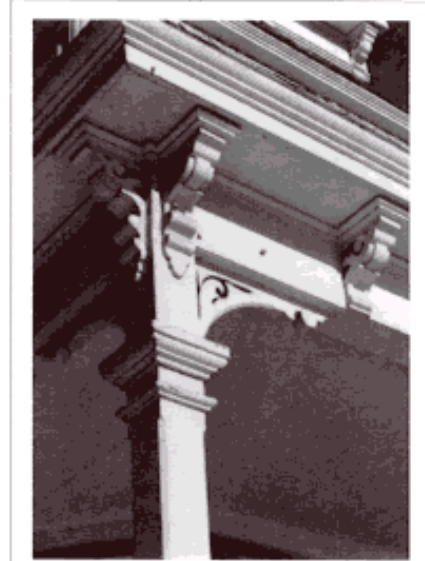
Wooden ornamental trim such as this can be duplicated with a jigsaw or purchased from reproduction catalogs

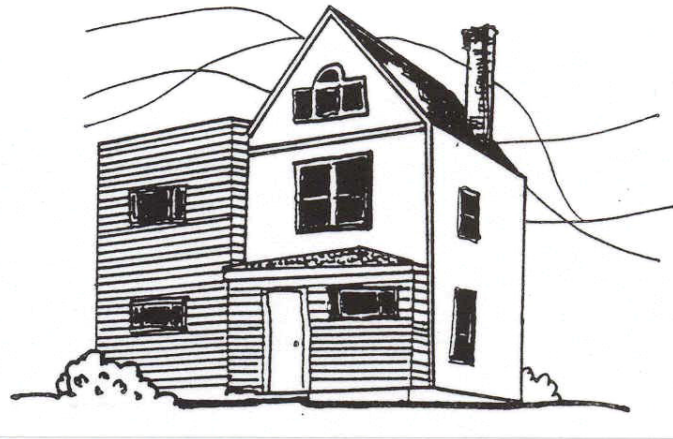
*INCOMPATIBLE ADDITION:*

- ◆ Different Roof Shapes
- ◆ Different Windows
- ◆ Different Materials
- ◆ Enclosed Front Porch

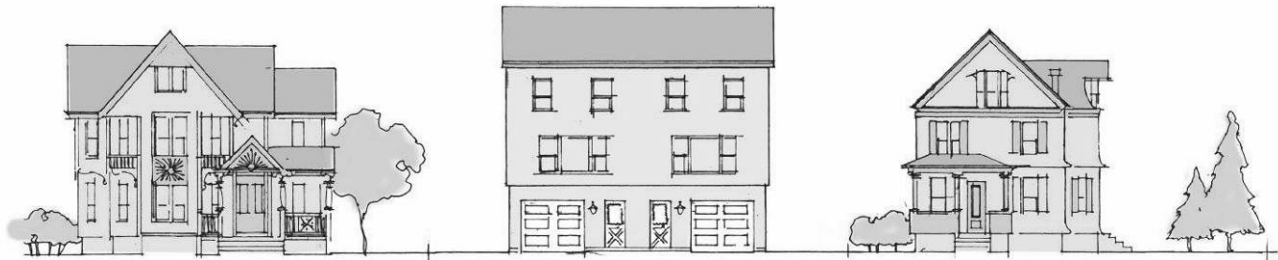
**An inappropriate “tuck under” infill house (center) on a traditional street**

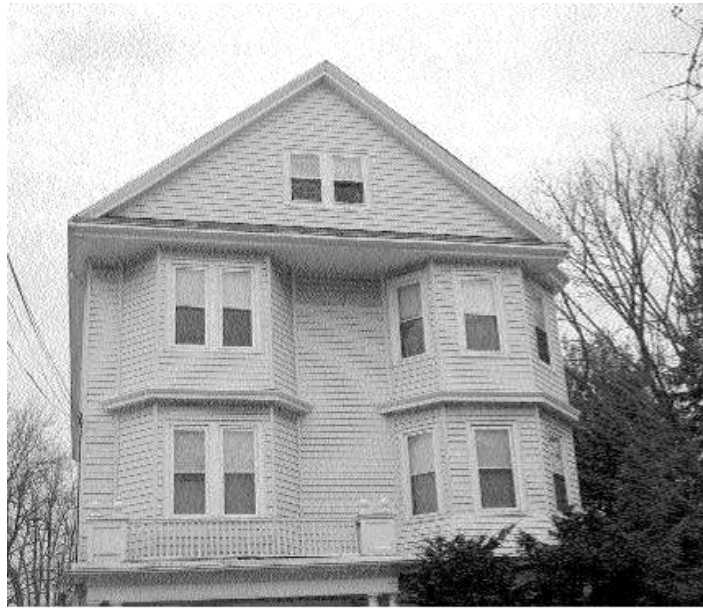
Building with original siding and ornamental trim covered or removed

Composite sidings and trim boards are a reality of life in present day building and remodeling. They protect wood frame structures from harsh elements and reduce the cost of maintenance for homeowners. However, the use of composite building materials should not result in the removal or obliteration of important architectural elements, designs and features on the structure.

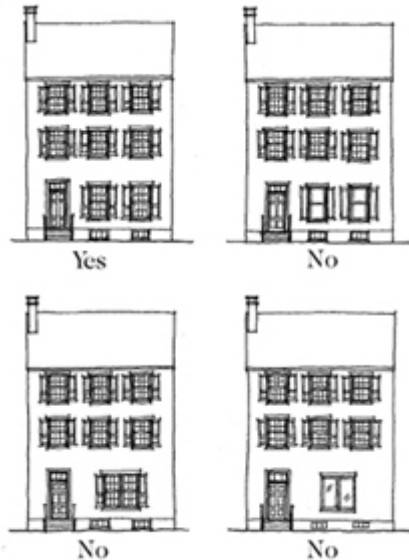
Preservation of the pattern and rhythm of historic windows is important to the harmony and texture of the building facade and the streetscape. Replacement of six-over-six sashes with one-over-one sashes destroys the scale of the windows (top right). Combining two windows into a single “picture window” or band of windows destroys the rhythm of the facade (bottom left and right). Modifying the alignment of windows and doors in each bay weakens the order of the facade.
